NEW RIVER BASIN

Name Of Dam: RURAL RETREAT DAM

Inventory Number: VA 19701

PHASE I INSPECTION REPORT

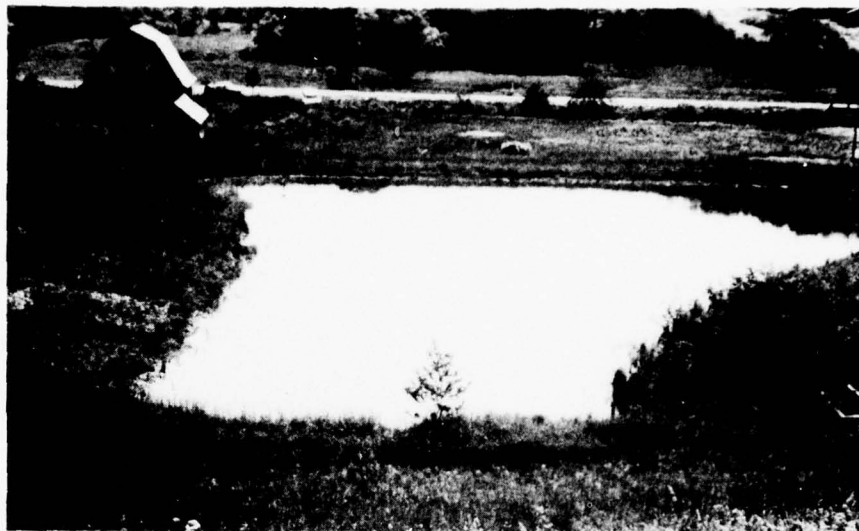
The minnow pond had well-vegetated slopes with no apparent seepage or sloughing. A 6-inch iron pipe was found exiting from the embankment at the base of the dam, leading to the minnow pond. Although evidently some type of drainage pipe, it was completely dry. The pipe was not shown on the plans.

MINNOW POND BELOW DAM AS VIEWED FROM THE CREST.

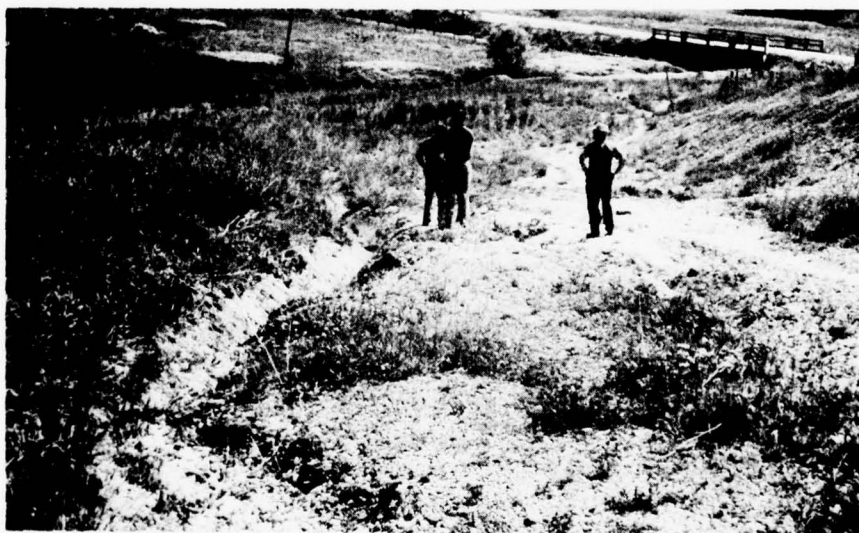
The spillway was found to have a capacity sufficient to pass 62 percent of a PMF. Although this is inadequate according to the Corps of Engineers' guidelines, it is not considered "seriously inadequate." The primary fault with the spillway is that it is not designed with sufficient consideration of the erosive capacity of a high velocity discharge. There is a good chance that under a large discharge flow severe erosion would occur.

SPILLWAY CHUTE SHOWING EROSION ON LEFT SIDE.

b. Spillway Protection: The spillway should be protected against erosion and slope instability. It is recommended that the owner enlist the services of a consultant to design an erosion resistant covering for the spillway crest and chute. The spillway capacity was not found to be "seriously inadequate", but future consideration should be given to enlarging it to meet the PMF design flood criteria. This work should be carried out in conjunction with the recommendation of paragraph b.

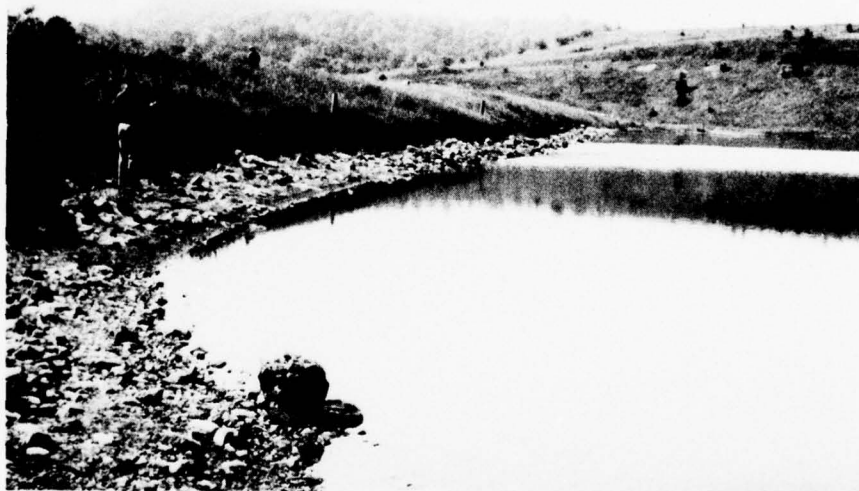
3.1 Findings: The downstream slope of the dam has well established vegetation, including several small trees (approximately 10 to 15 feet high) near the left abutment, and one tree at the dam center, near the one-third point along the slope. In addition to the trees, several holes burrowed by animals were also seen in the abutment area. A complete failure of the riprap along the shoreline has resulted in severe erosion of the upstream face.

UPSTREAM FACE OF DAM SHOWING RIPRAP FAILURE
AND SEVERE EROSION OF THE SLOPE June 1978

A wave cut bench was also noted on the upstream face of the dam indicating the presence of insufficient rip rap.

c. Slope Repair: The upstream slope should be repaired and new riprap installed on the slope. This should be done within 90 days.
